Densah™ Bur Technology At Work:

Case: 64 year old male patient presented with missing maxillary right canine

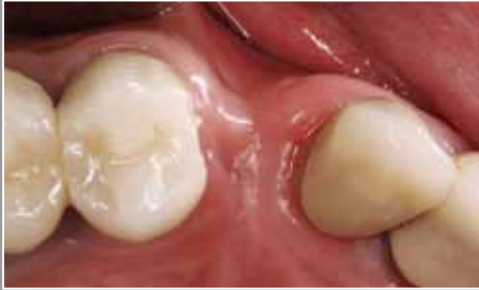
1 - Significant loss in alveolar ridge due to buccal plate resorption

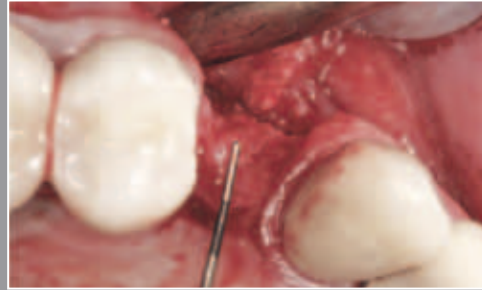
2 - Alveolar ridge width after flap reflection measuring 3 mm

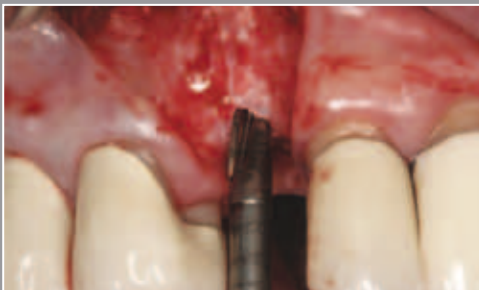
3 - Densah Bur 1828 osseodensification mode 1200 RPM (non-cutting direction)

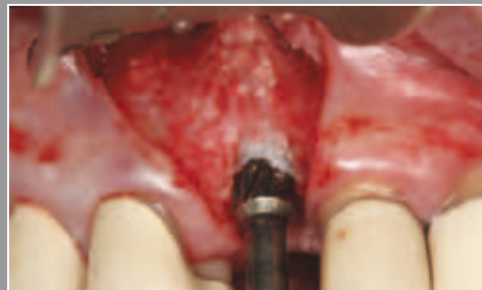
4 - Densah Bur 2838 Osseodensification mode 1200 RPM (Non-cutting direction)

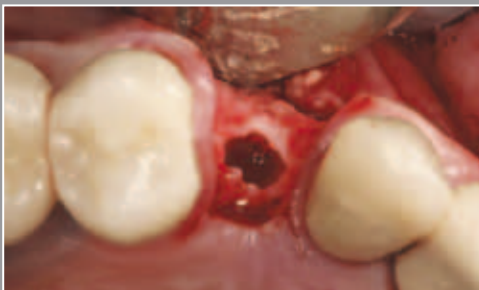
5 - Osseodensification facilitated ridge expansion with compaction Autografting

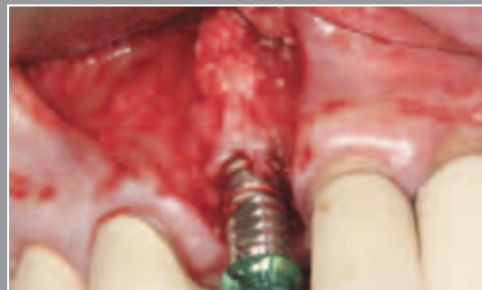
6 - 4.2 mm fixture placed. Evidence of ridge expansion with no fenestration

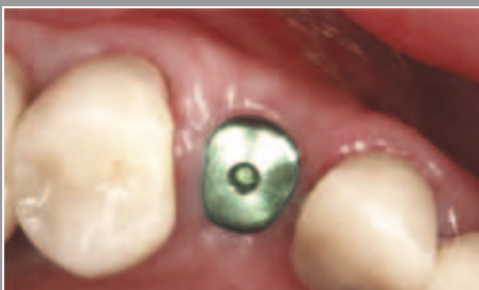
7 - 3 wks healing with apparent ridge expansion

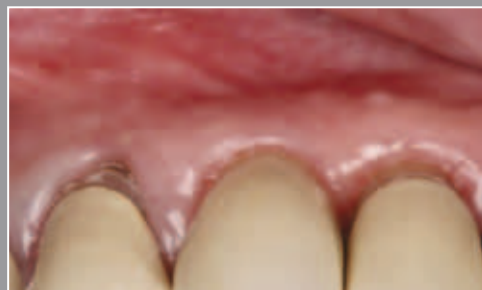
8 - Final Restoration with adequate buccal ridge anatomy
